# 2007 ANNUAL INSPECTION, MONITORING AND MAINTENANCE REPORT 1 ½ MILE REMOVAL REACH GENERAL ELECTRIC (GE)/HOUSATONIC RIVER SITE Environmental Remediation Contract GE/Housatonic River Project Pittsfield, Massachusetts

DCN: GE-010808-ADSO

January 2008

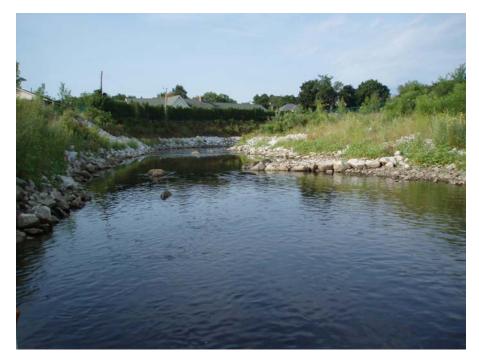
Aquatic Habitat Enhancement Structures – The aquatic habitat enhancement structures appear to be stable, as-built condition and performing as designed, as indicated by variations in current speed, turbulence, and sediment deposition adjacent to the structures (Photo 1). Scour of riverbed or riverbank riprap was not observed adjacent to any of the observed structures. Sediment deposition was observed adjacent to some of the aquatic habitat structures, further indicating that the presence of the structures is providing diversity of aquatic habitat.

Photo 1: Aquatic Habitat Structures, Monitoring Area 1

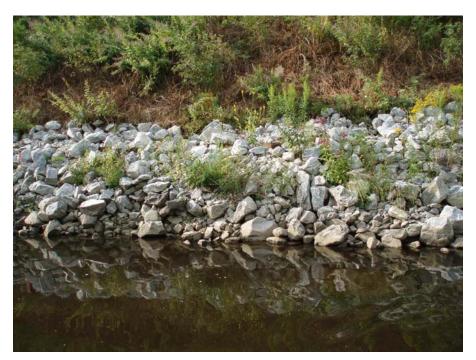
Aquatic Habitat Enhancement Structures – The aquatic habitat enhancement structures appear to be stable, as-built condition and performing as designed, as indicated by variations in current speed, turbulence, and sediment deposition adjacent to the structures (Photos 4 and 5). Scour of riverbed or riverbank riprap was not observed adjacent to any of the observed structures. Sediment deposition was observed adjacent to some of the aquatic habitat structures, further indicating that the presence of the structures is providing diversity of aquatic habitat.

Photo 4: Aquatic Habitat Structures, Monitoring Area 2 Looking Upstream at Elm Street Bridge

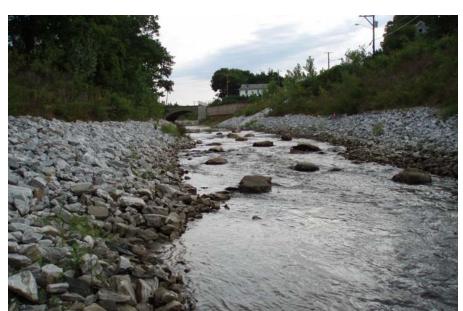
Photo 5: Riffle/Run Development, Monitoring Area 2

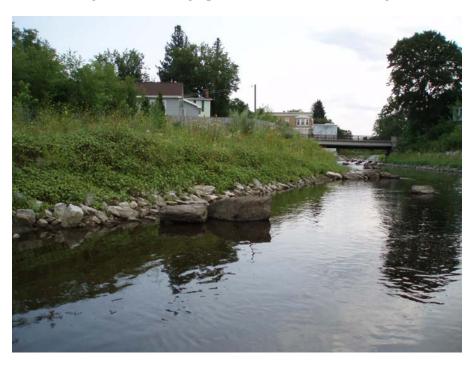
**Riverbank Riprap** – No deficiencies in the riverbank riprap were observed. The riverbank riprap was not observed in areas where sedimented material has accreted (Photos 7 and 8).

Photo 8: Aquatic Habitat Structures and Vegetated Streambanks, Monitoring Area 3

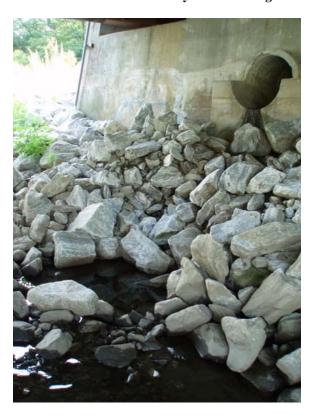
**Riverbank Riprap** – No deficiencies in the riverbank riprap were observed. The riverbank riprap was not observed where sedimented material has accreted (Photo 10).

Photo 10: Riverbanks and Aquatic Habitat Structures, Monitoring Area 4
